Hydrogeologic Appraisal of the Cayuga County Ground-Water Contamination Superfund Site near Auburn, NY

David A. Eckhardt, USGS, Ithaca, NY

**U. S Department of the Interior
U. S. Geological Survey**

**In cooperation with
U. S. Environmental Protection Agency**

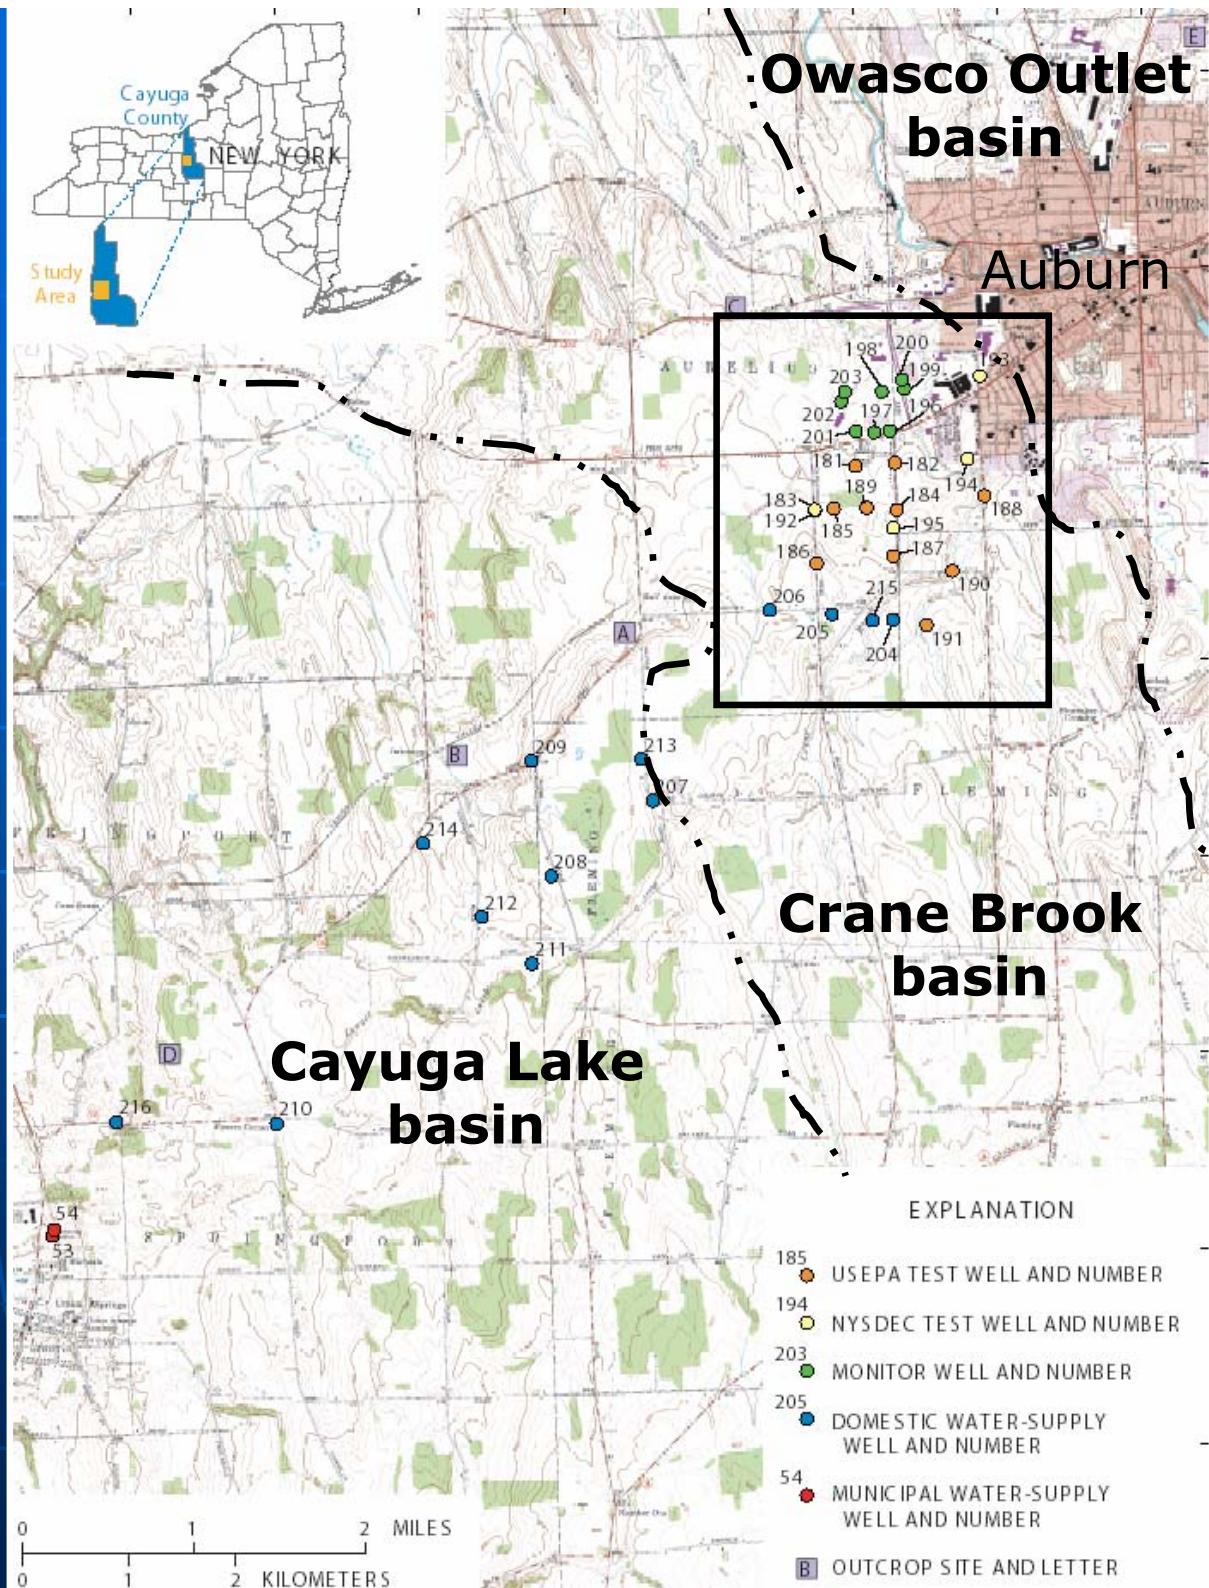
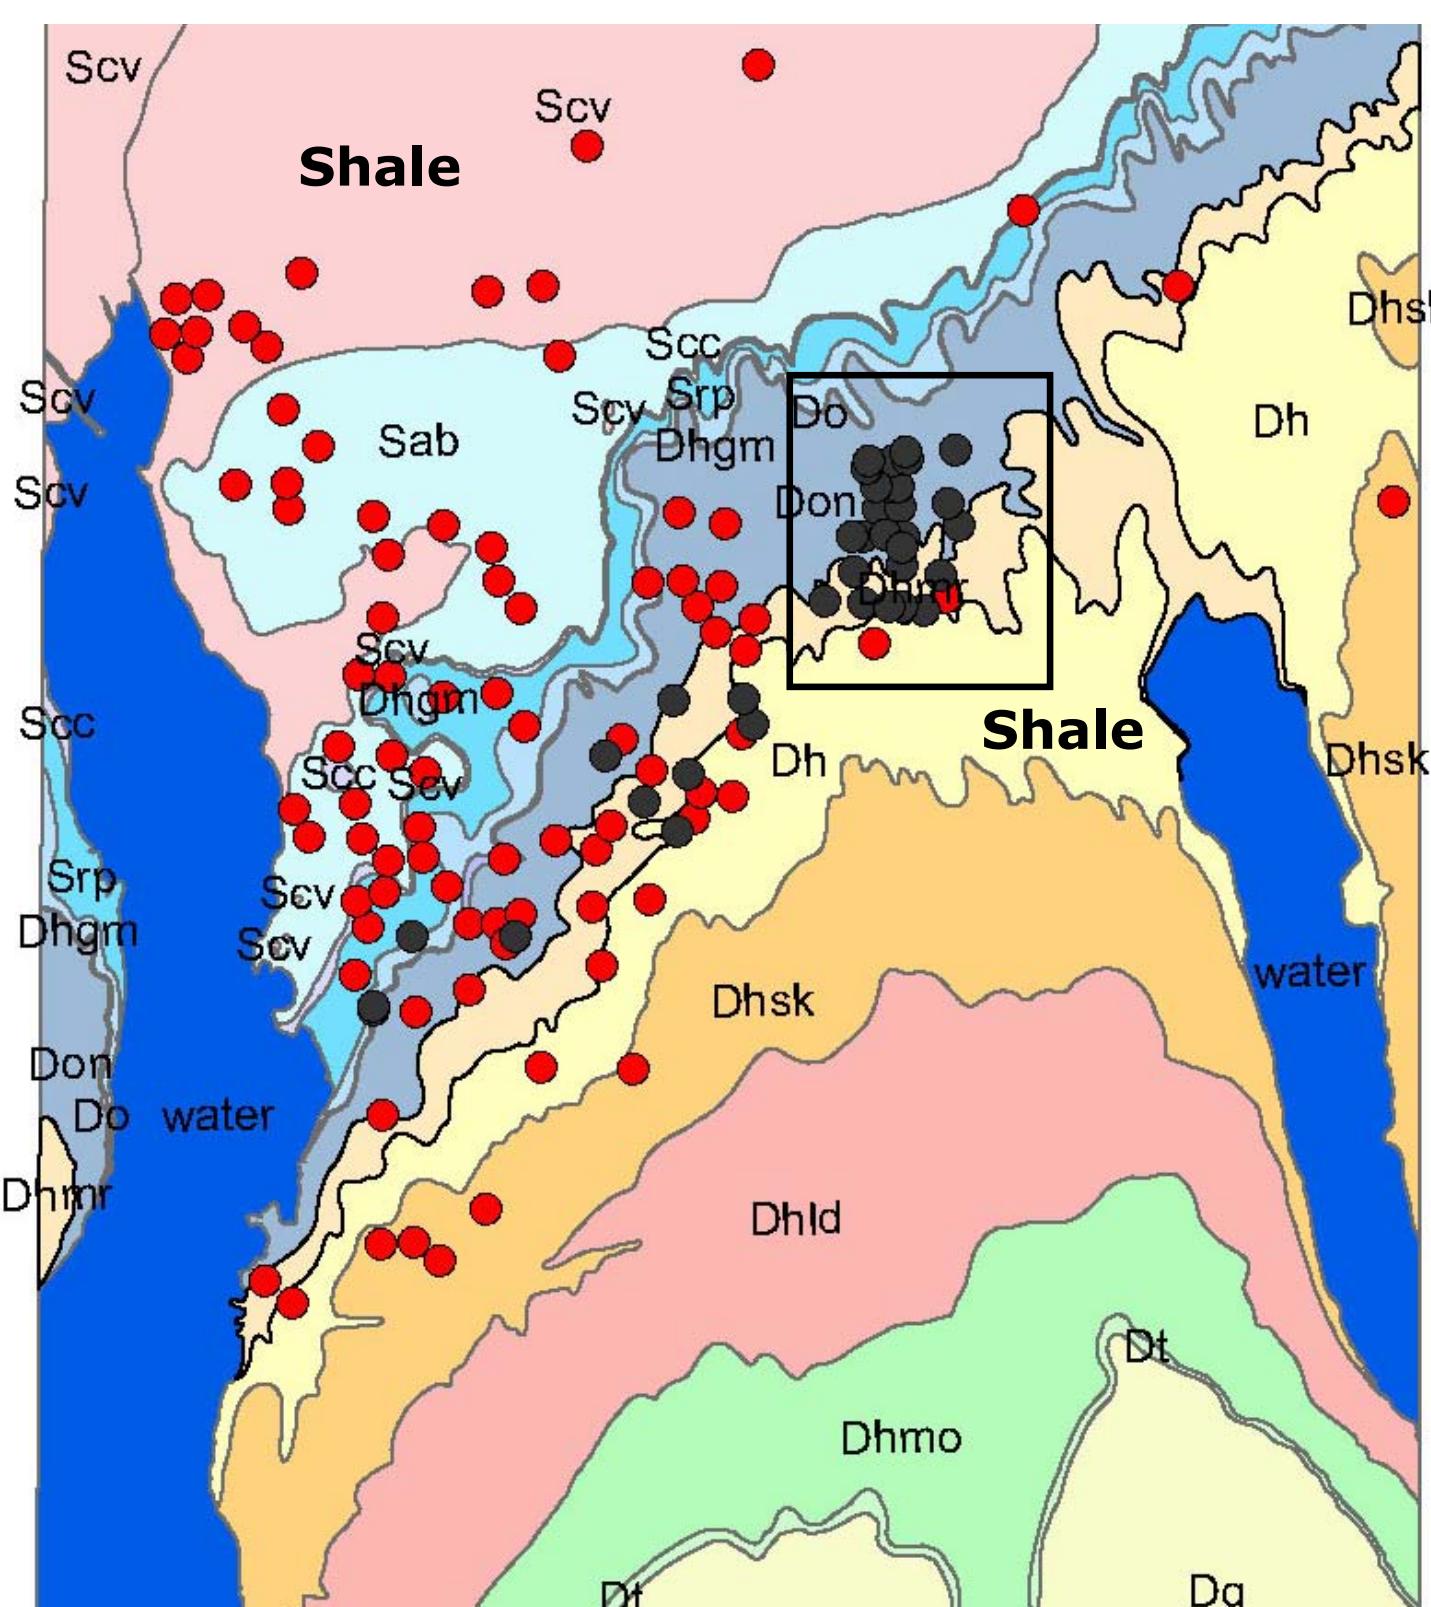
Location of wells at the Cayuga County site

Wells with borehole geophysical logs

- Gas well
 - Monitoring well

Don, Onondaga Limestone
Dhgm, Manlius, Rondout
Scc, Cobleskill Formation
Sab, Bertie Formation

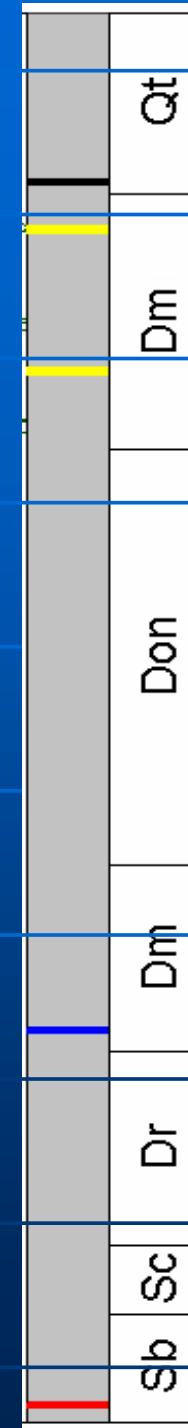
Regional stratigraphic sequence and borehole flow in recharge areas

Base of casing

Flow zones with
hydraulic head
above composite
head

Composite
Hydraulic head

Flow zone with
hydraulic head
below composite
head

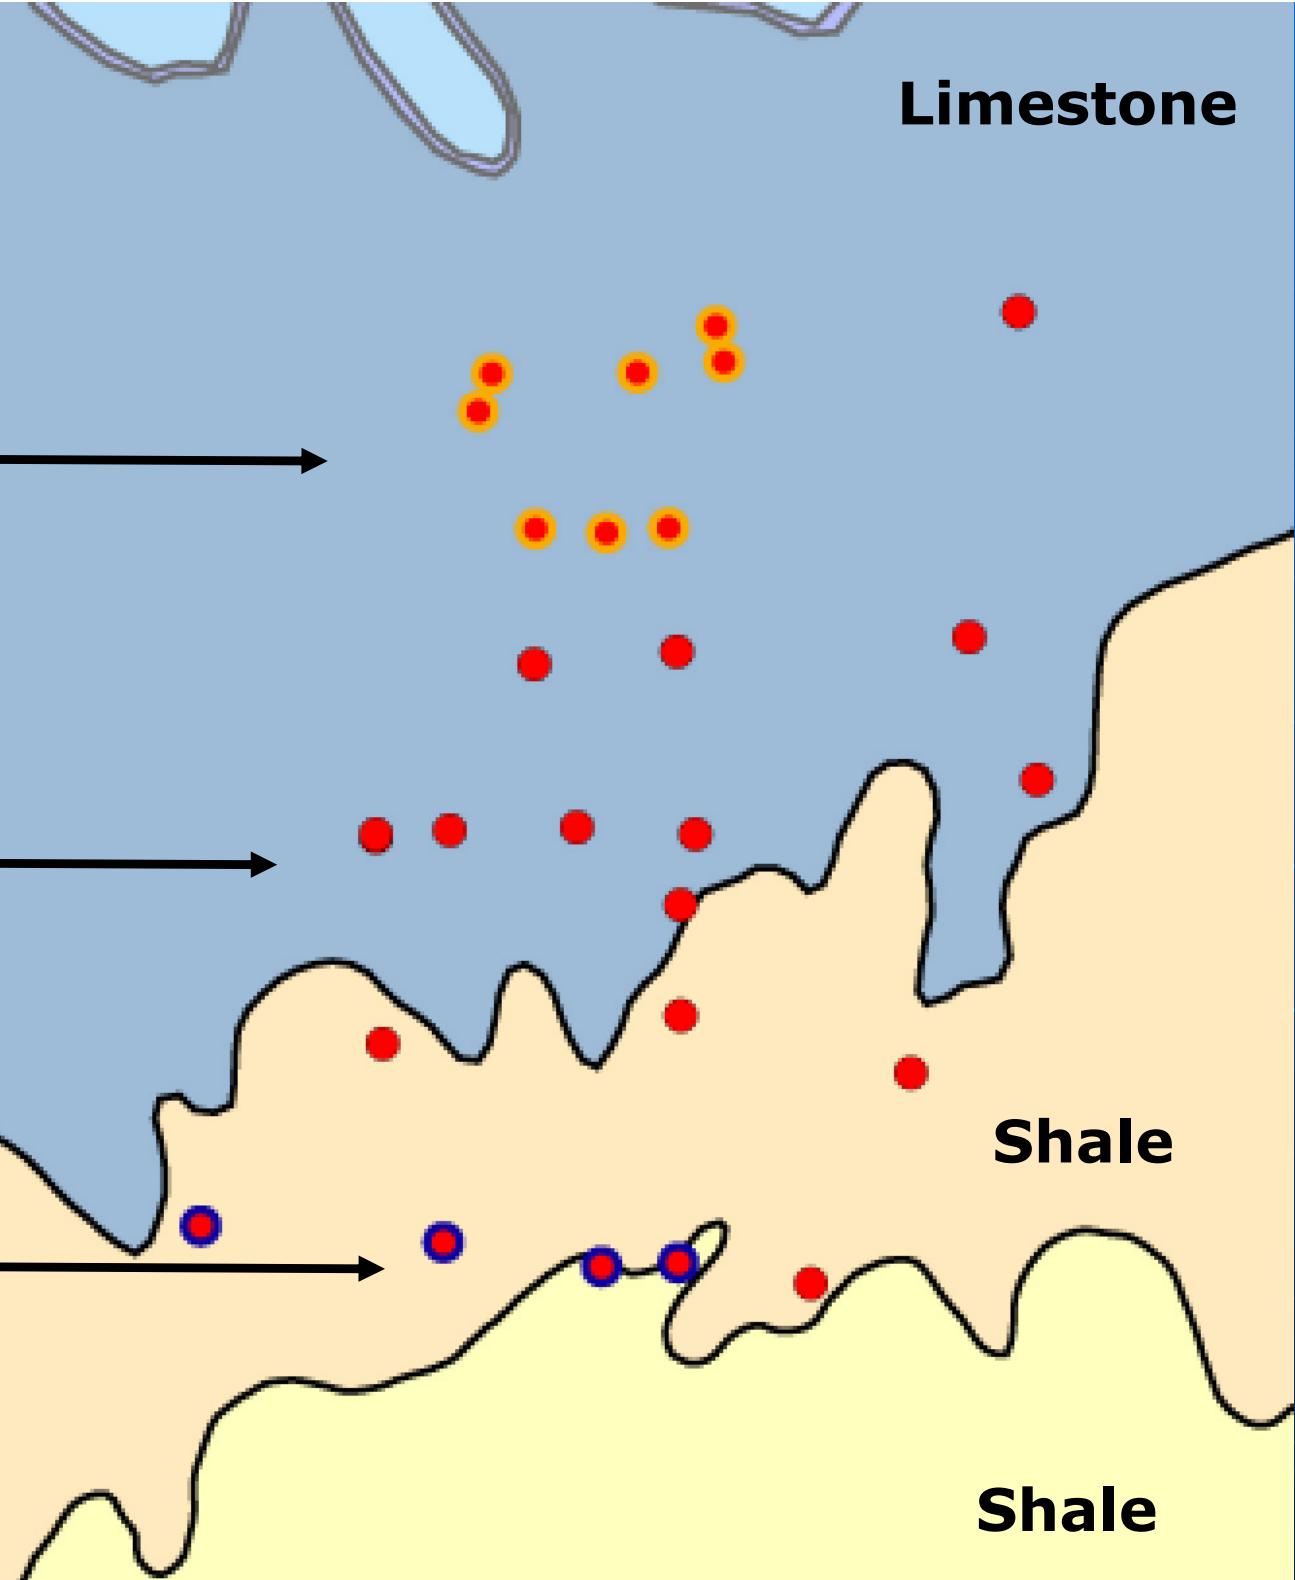
Ground water at the monitor wells in the Onondaga Limestone flows NW and NE

Ground water at the EPA test wells in the Bertie Fm. flows South then SW

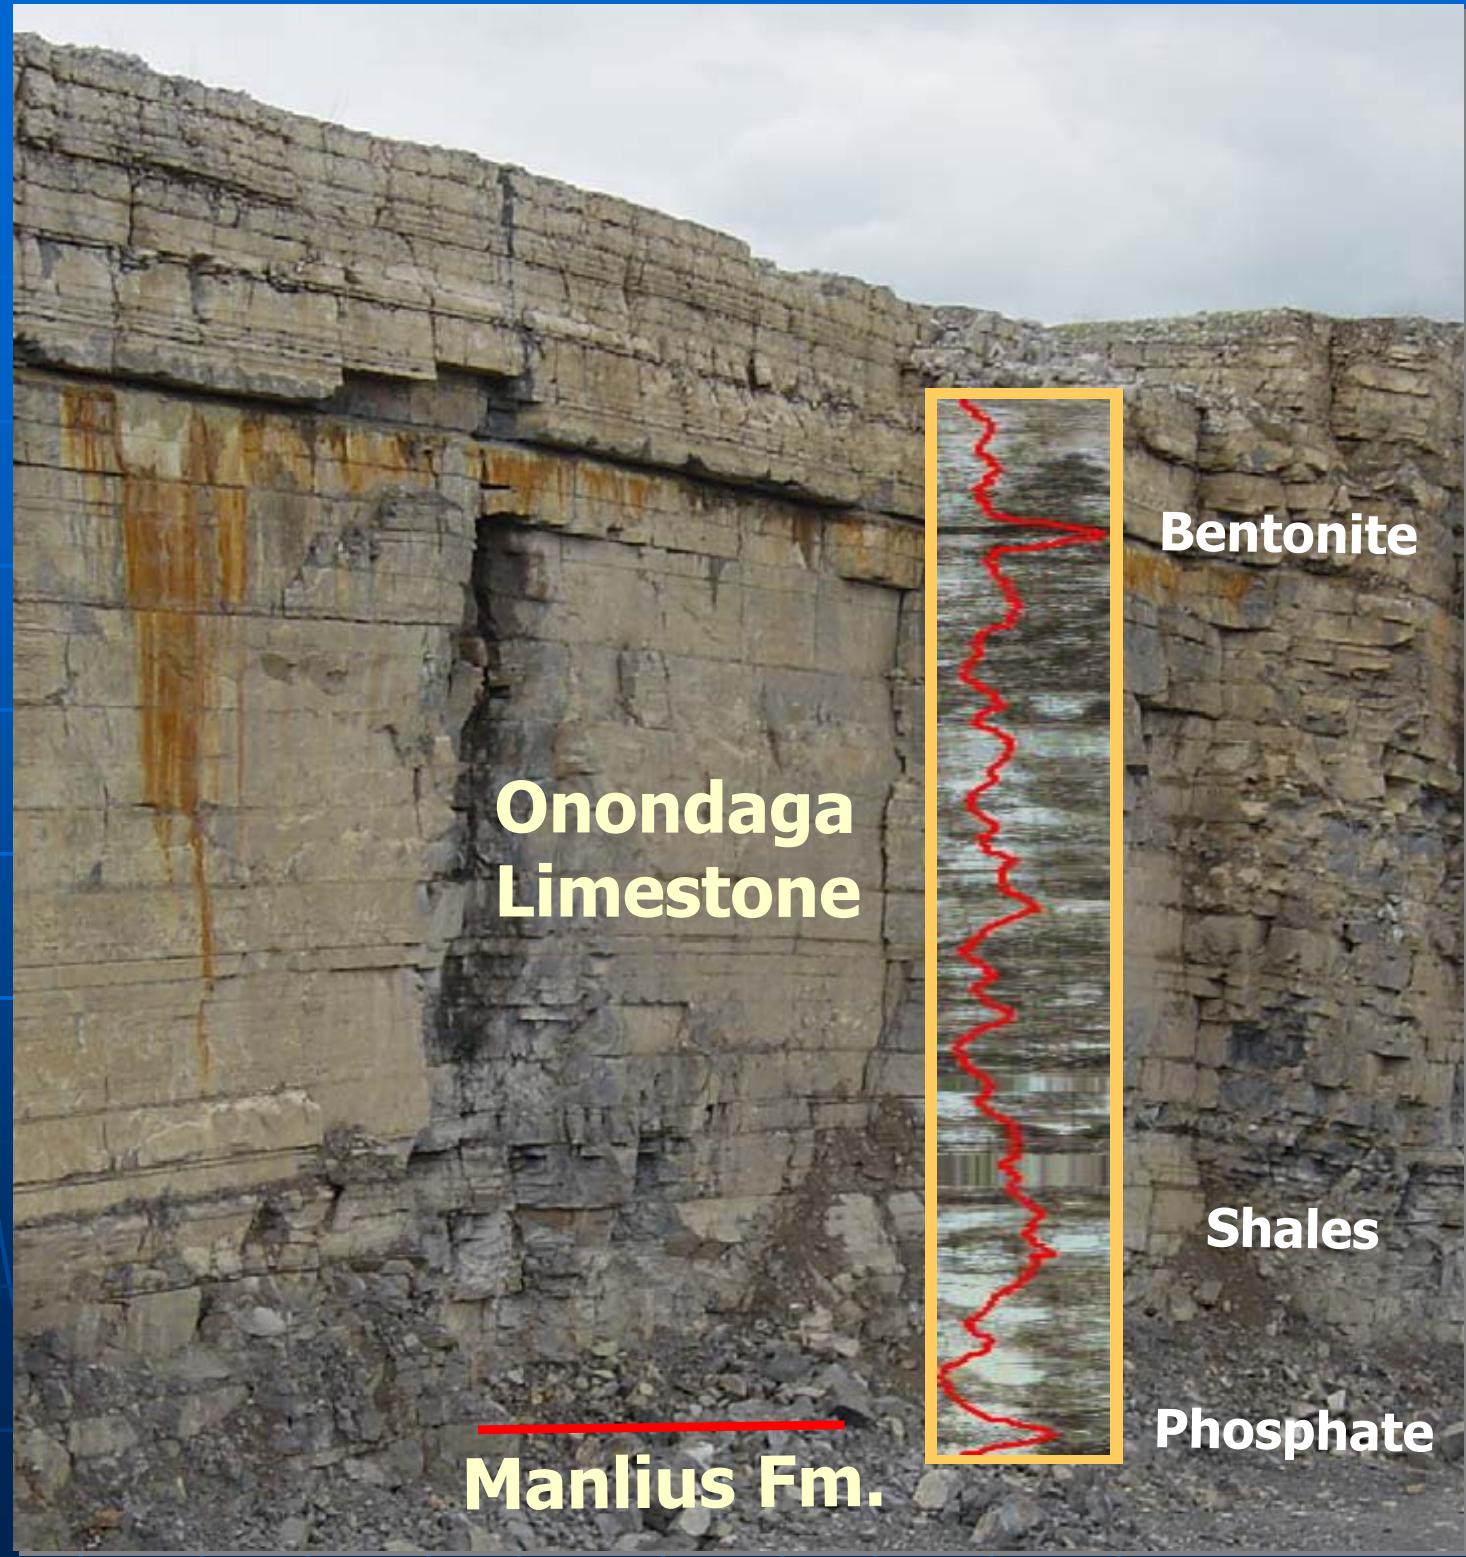
**Use of typical
stratigraphic
marker beds
that are easily
identified in
gamma logs**

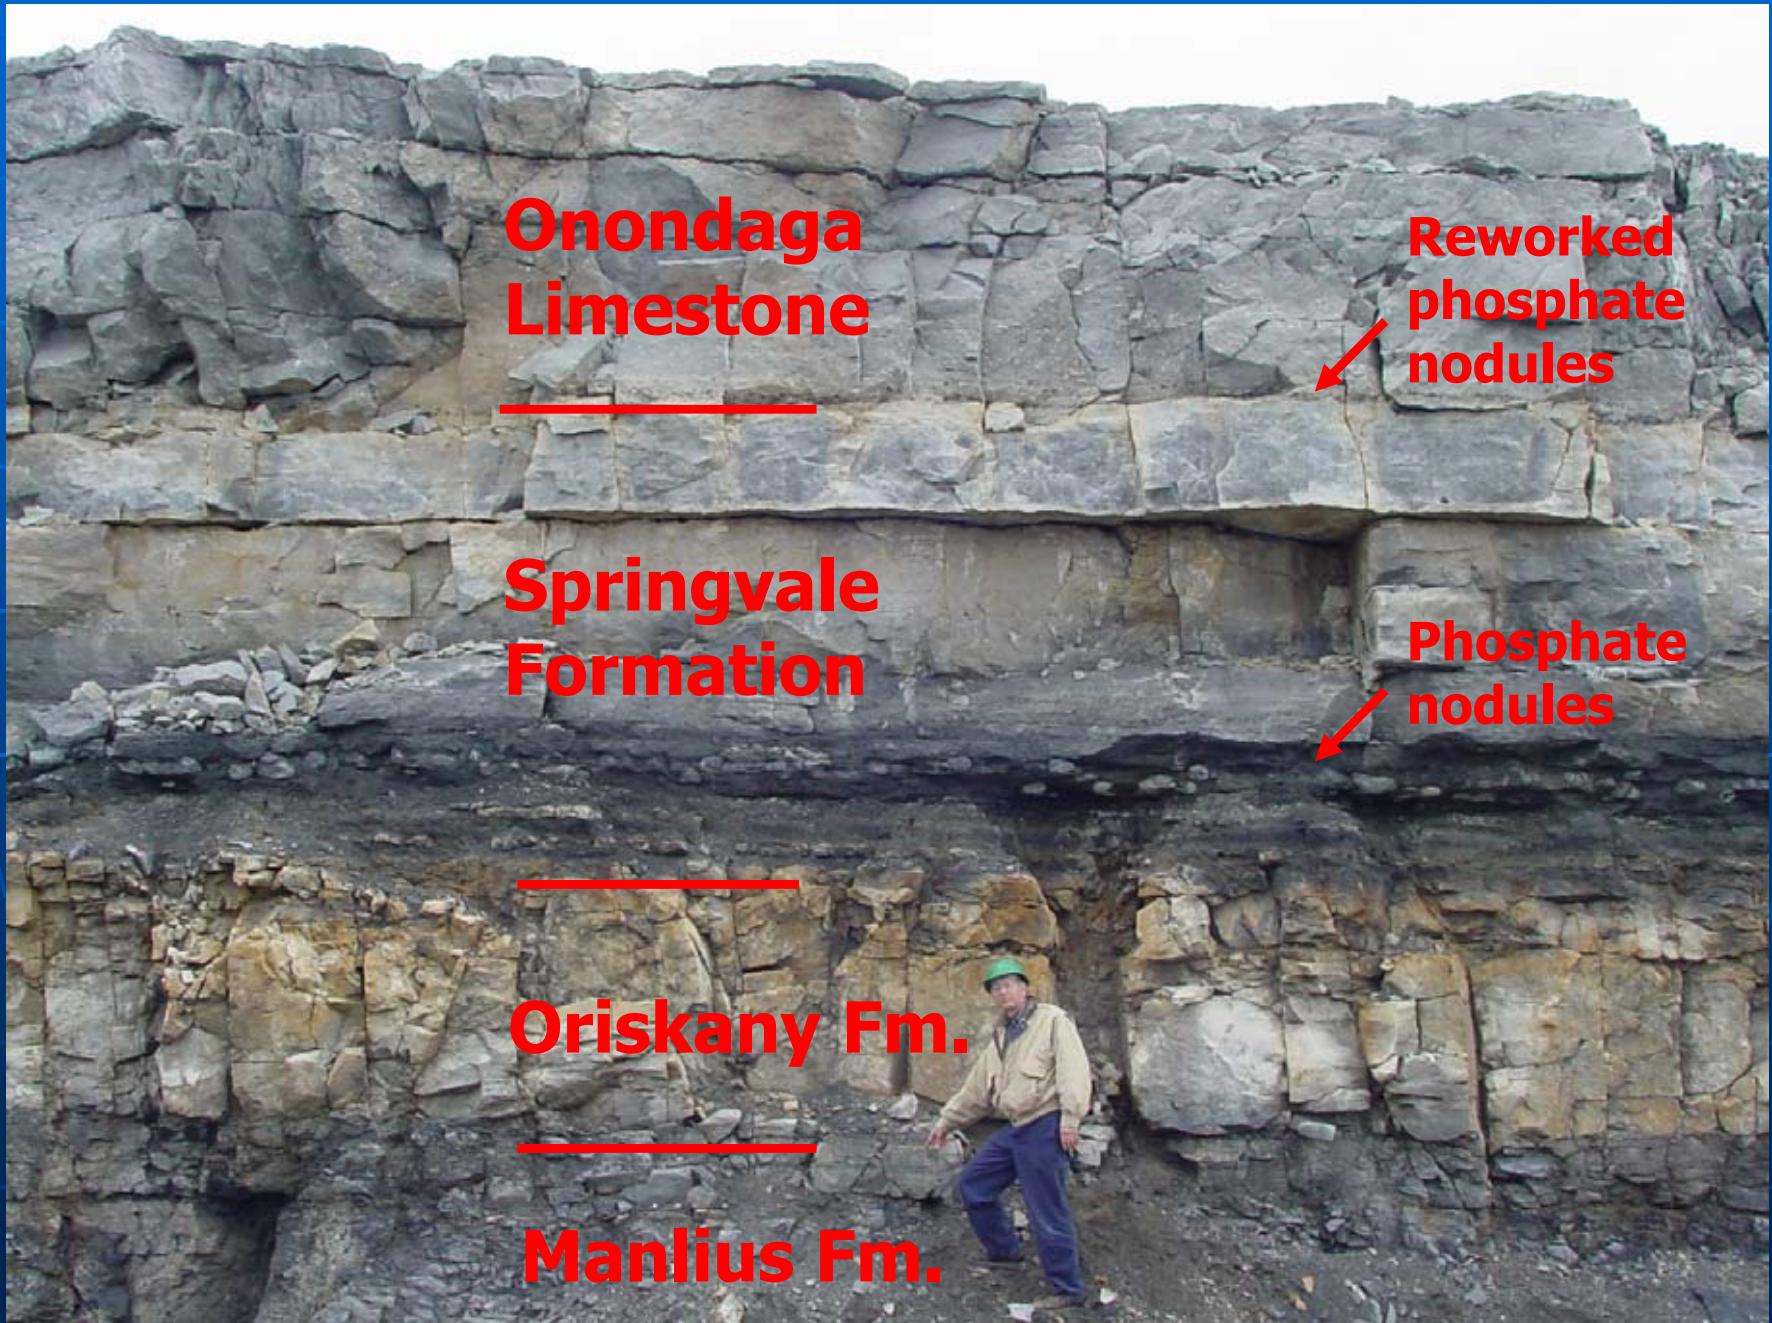
Phosphate marker beds at base of Onondaga (in Skaneateles Quarry, 15 miles east of Auburn)

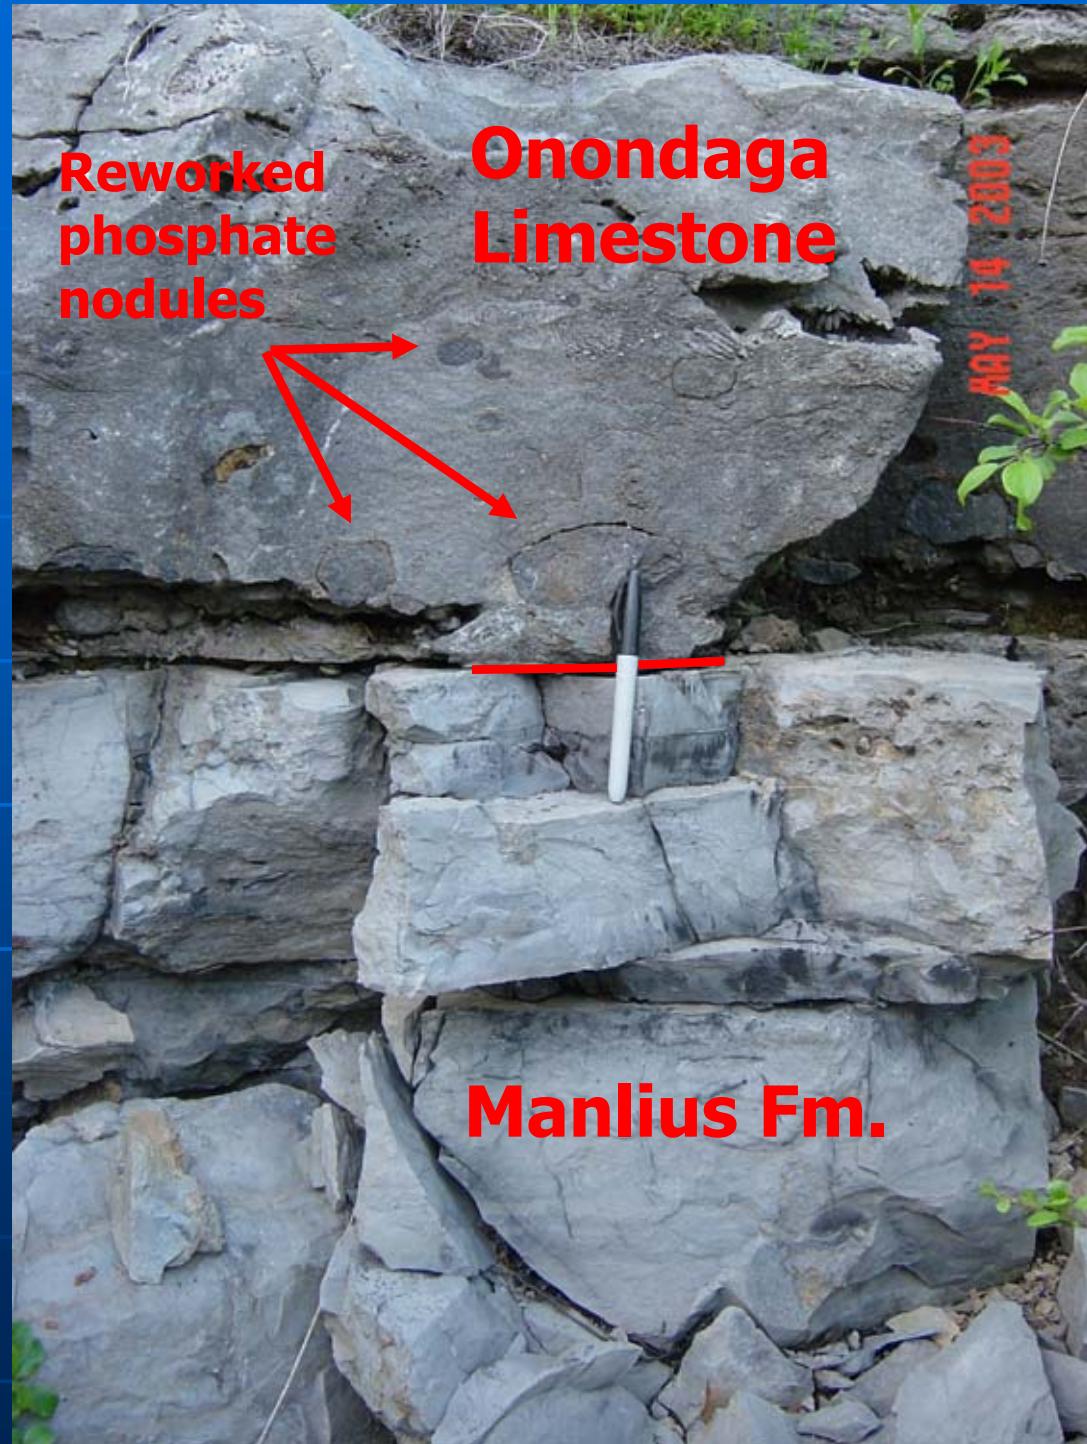
**Phosphate marker
beds at base of
Onondaga to north
of RCRA plant)**

**(Springvale and
Oriskany beds
not present)**

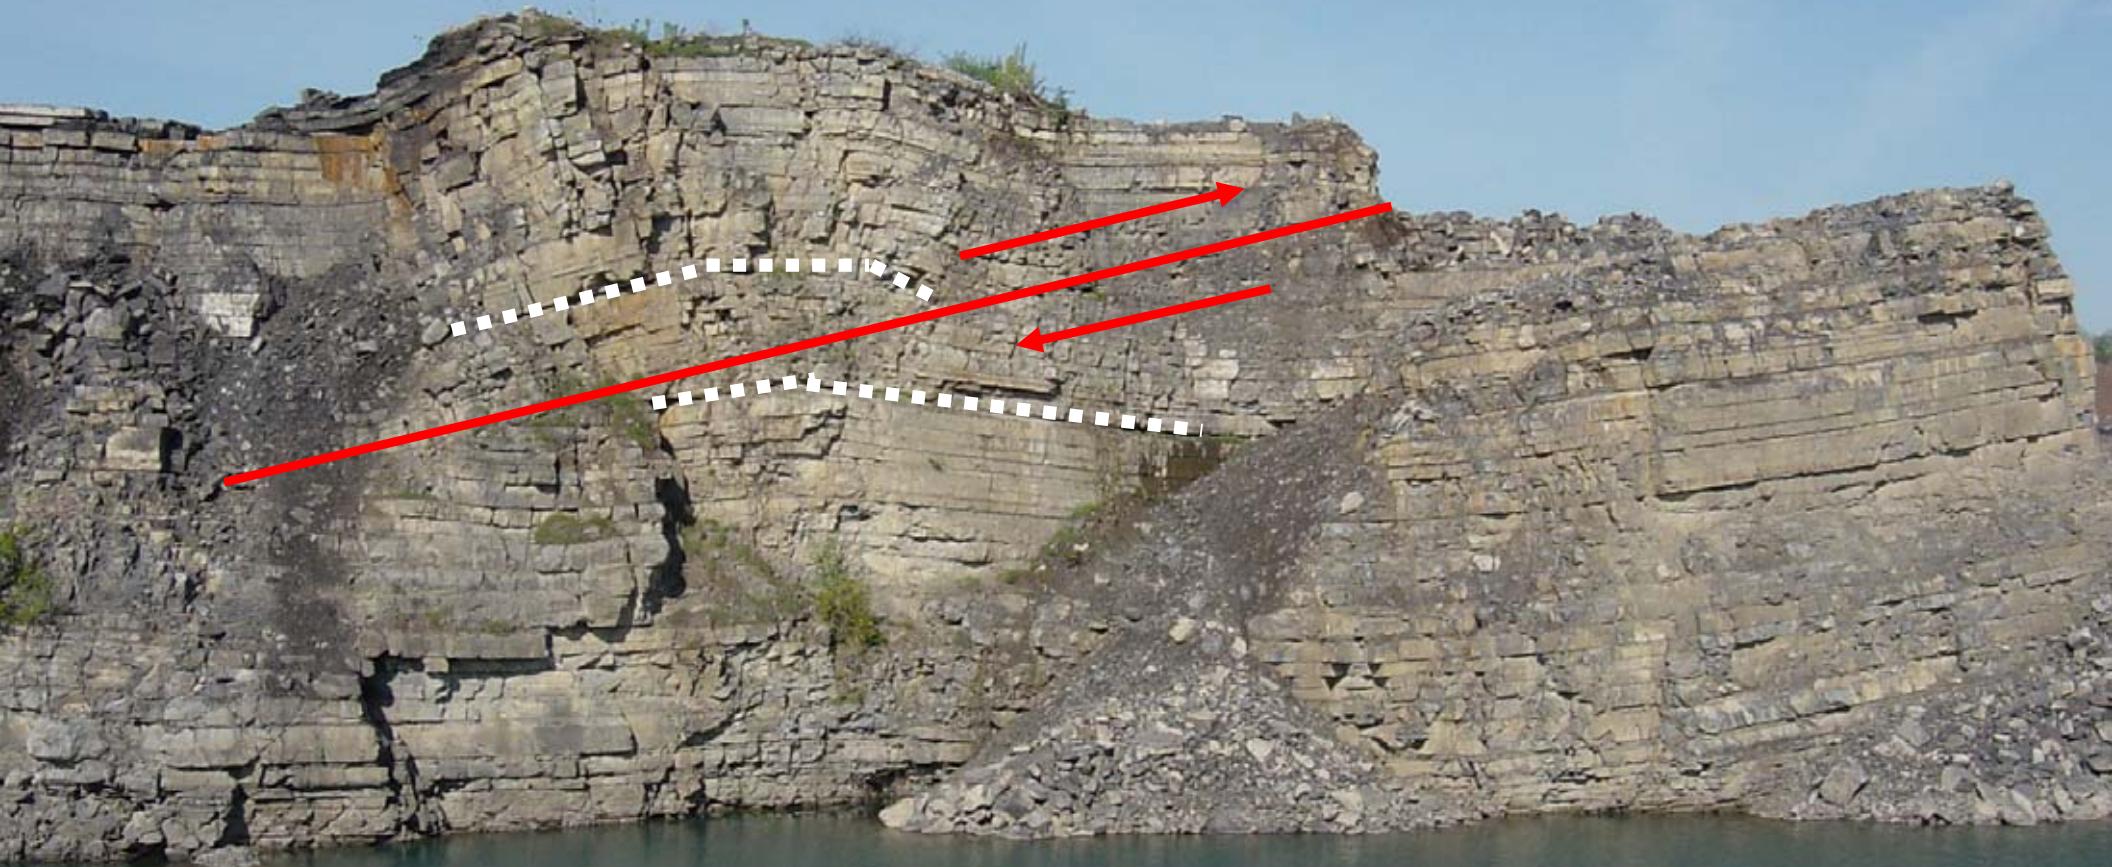
**Low-angle thrust fault
in the Onondaga Limestone
at the Seneca Stone Quarry
(15 miles southwest of Auburn)**

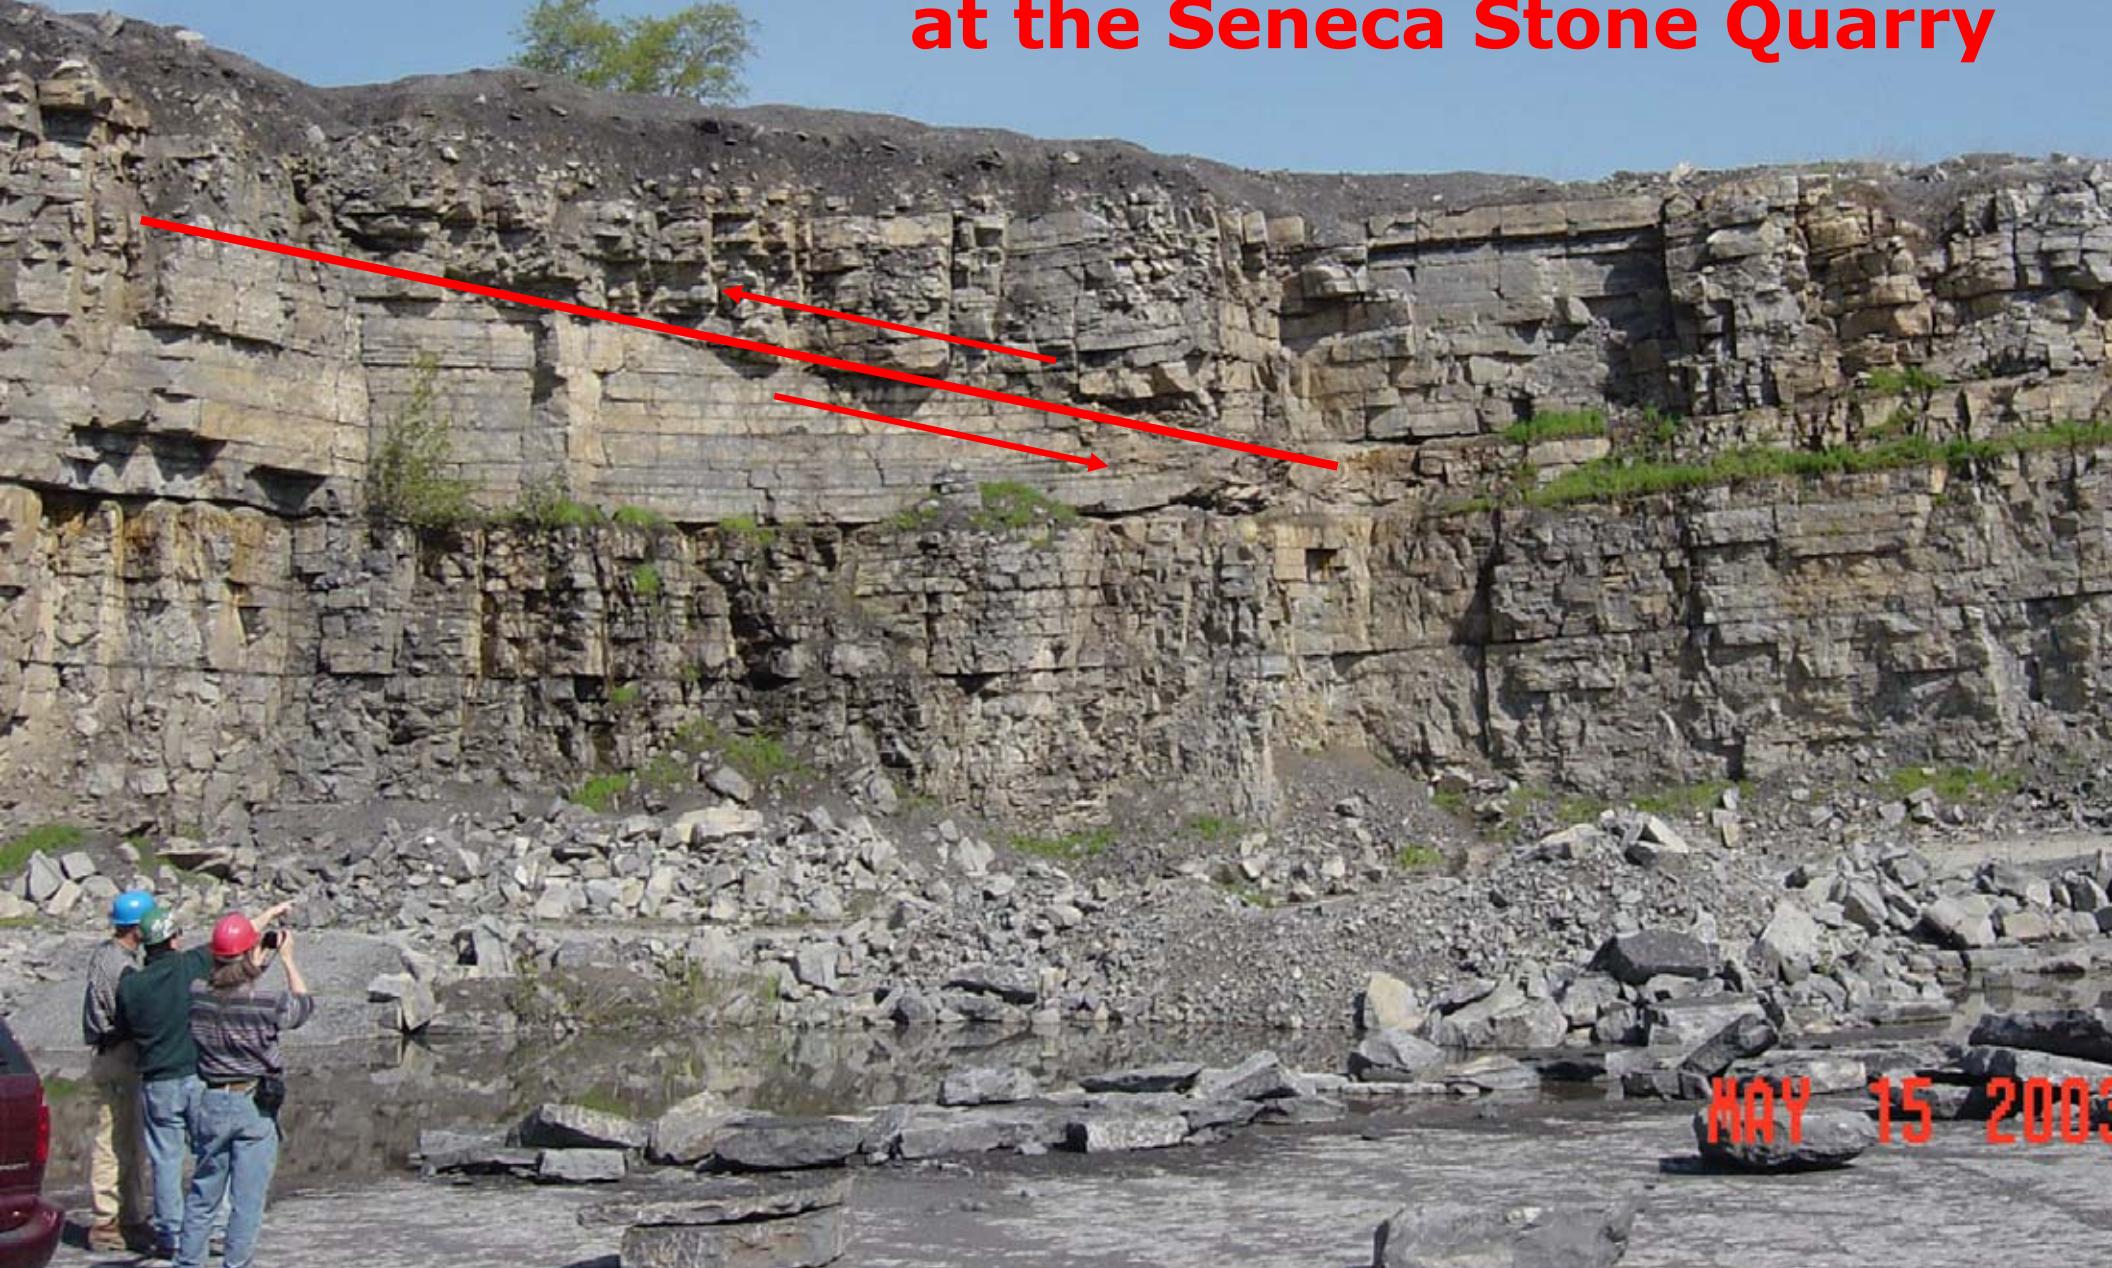
**Low-angle thrust fault
in the Onondaga Limestone
at the Seneca Stone Quarry**

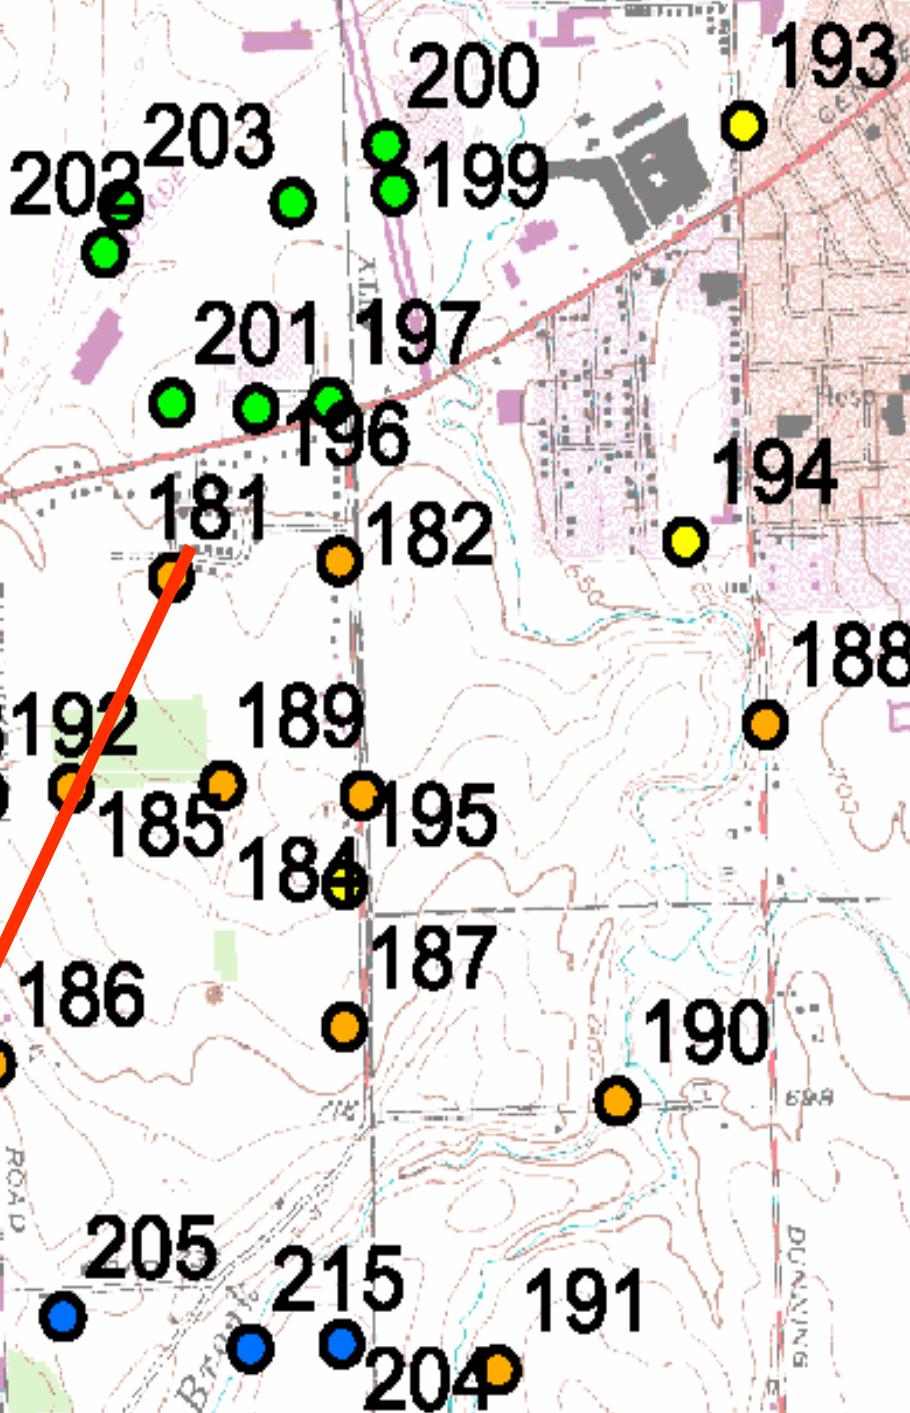
**North-South
hydrogeologic
section shows
nominal
stratigraphy**

NORTH

Elmhurst Dr. — Pinckney Rd.

SOUTH

ELEVATION, IN FEET

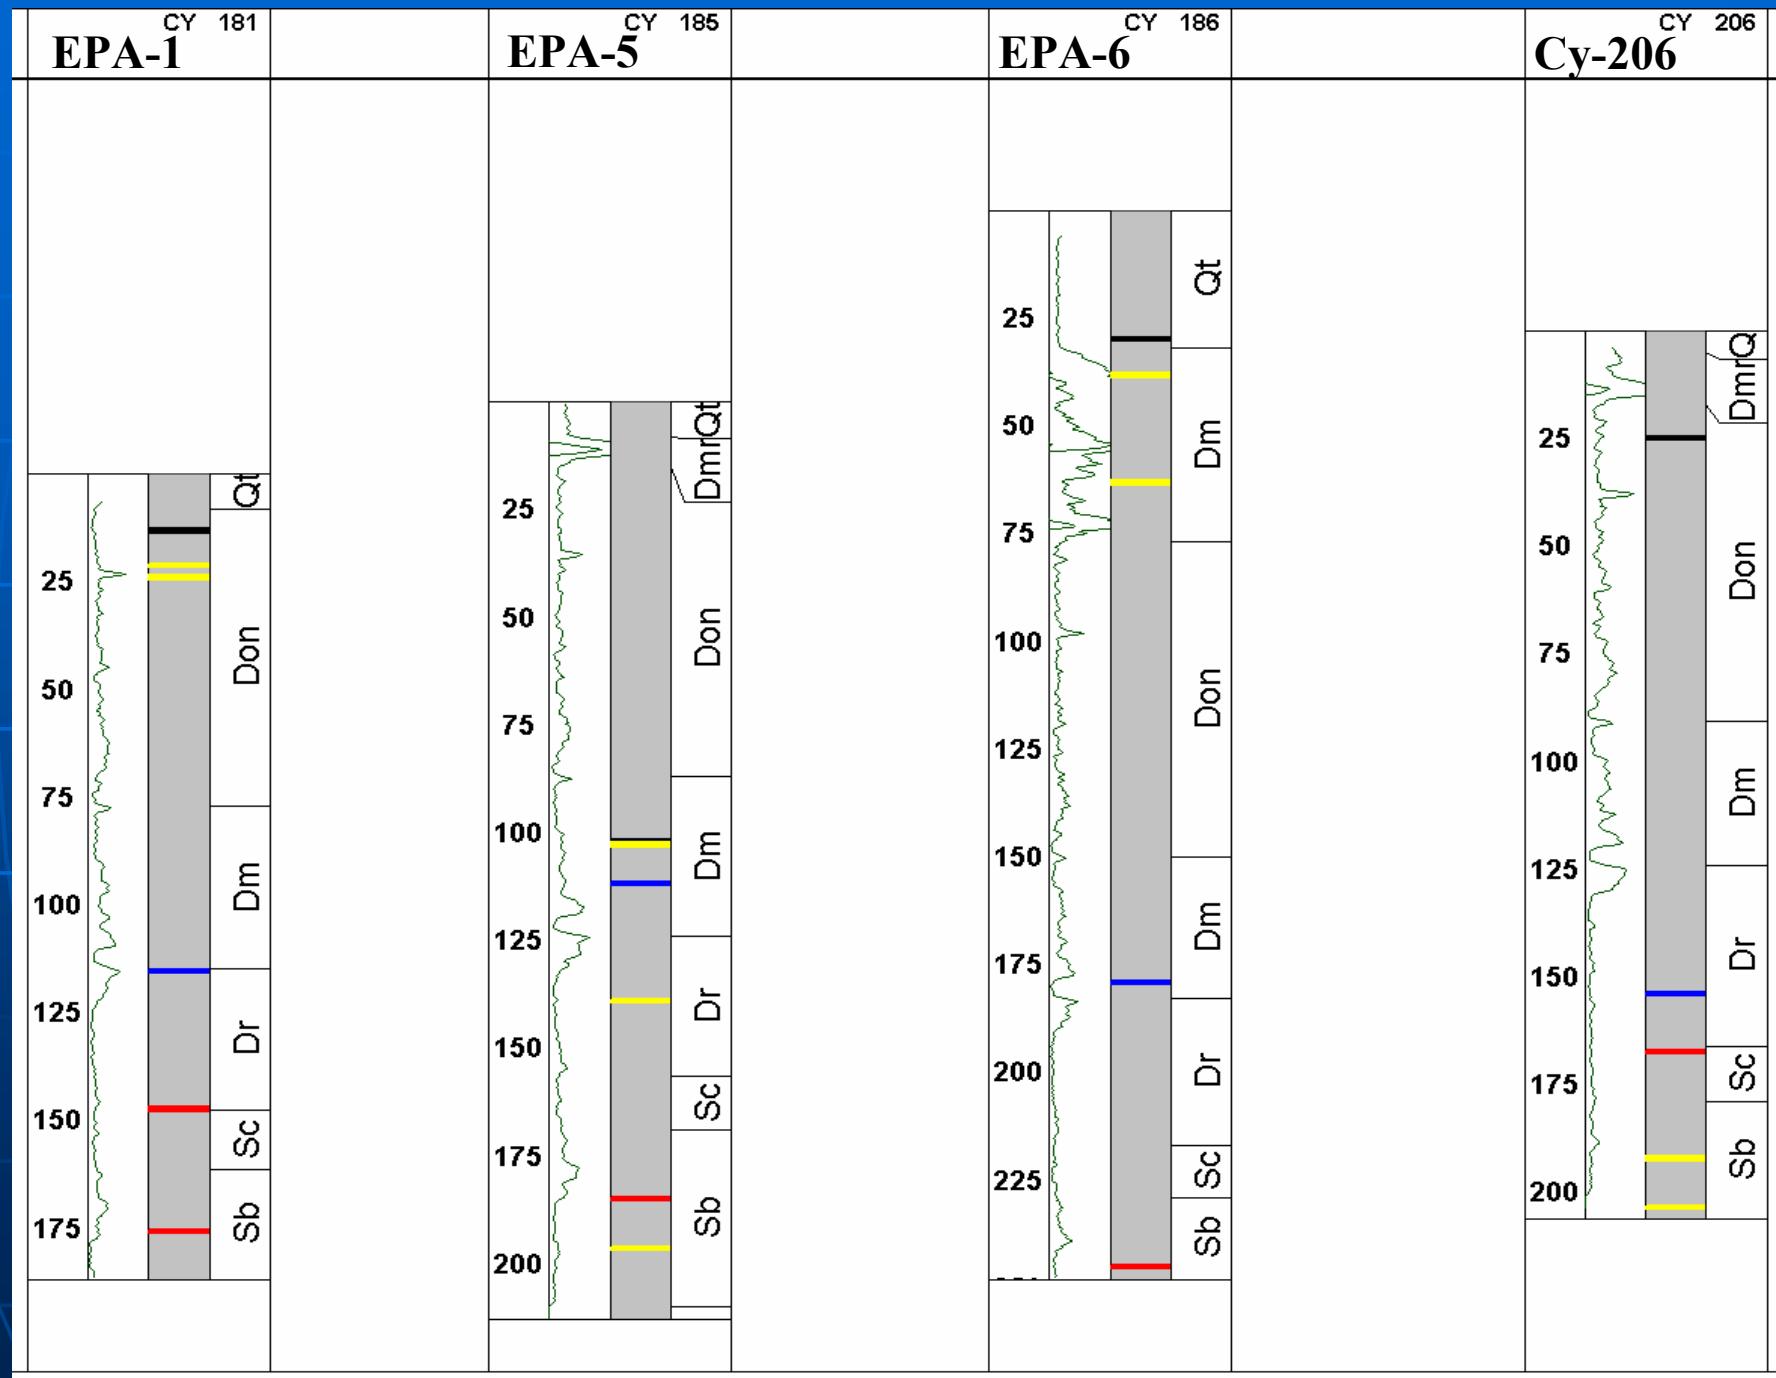
EPA-1

Geophysical, Stratigraphic, and Flow-Zone Logs
